# Manhole Inspection Summary

Manhole # S43M\_\_029MH

Insp Date: **6/5/08 12:03 PM**

**Location** Address: **801 caroline st**

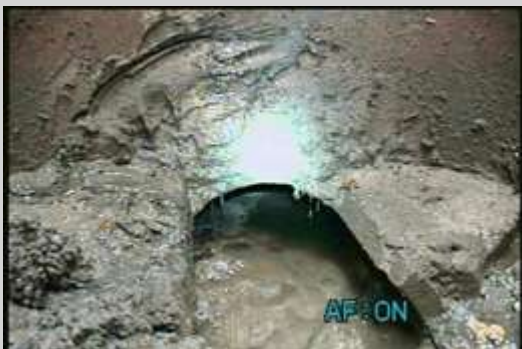
6 O'Clock Inflow

15 in. Circular Gravity Sewer  
Pipe In @ 6 O'Clock

Pipe Height: 0 (in.) Direct

Pipe Material: **Clay** ☐ Pipe Lined

Infiltration: **None** Pipe Seal Cond: **Unknown**
